OCEAN ENGINEERING AND CONSTRUCTION PROJECT OFFICE
CHESAPEAKE DIVISION
NAVAL FACILITIES ENGINEERING COMMAND
WASHINGTON, D. C. 20374

INDIAN ISLAND MOORING PROJECT PHASE II COMPLETION REPORT

**FPO - 1 - 84 (2)
MARCH 1984**

**ROBERT TAGGART INCORPORATED
FAIRFAX, VIRGINIA**

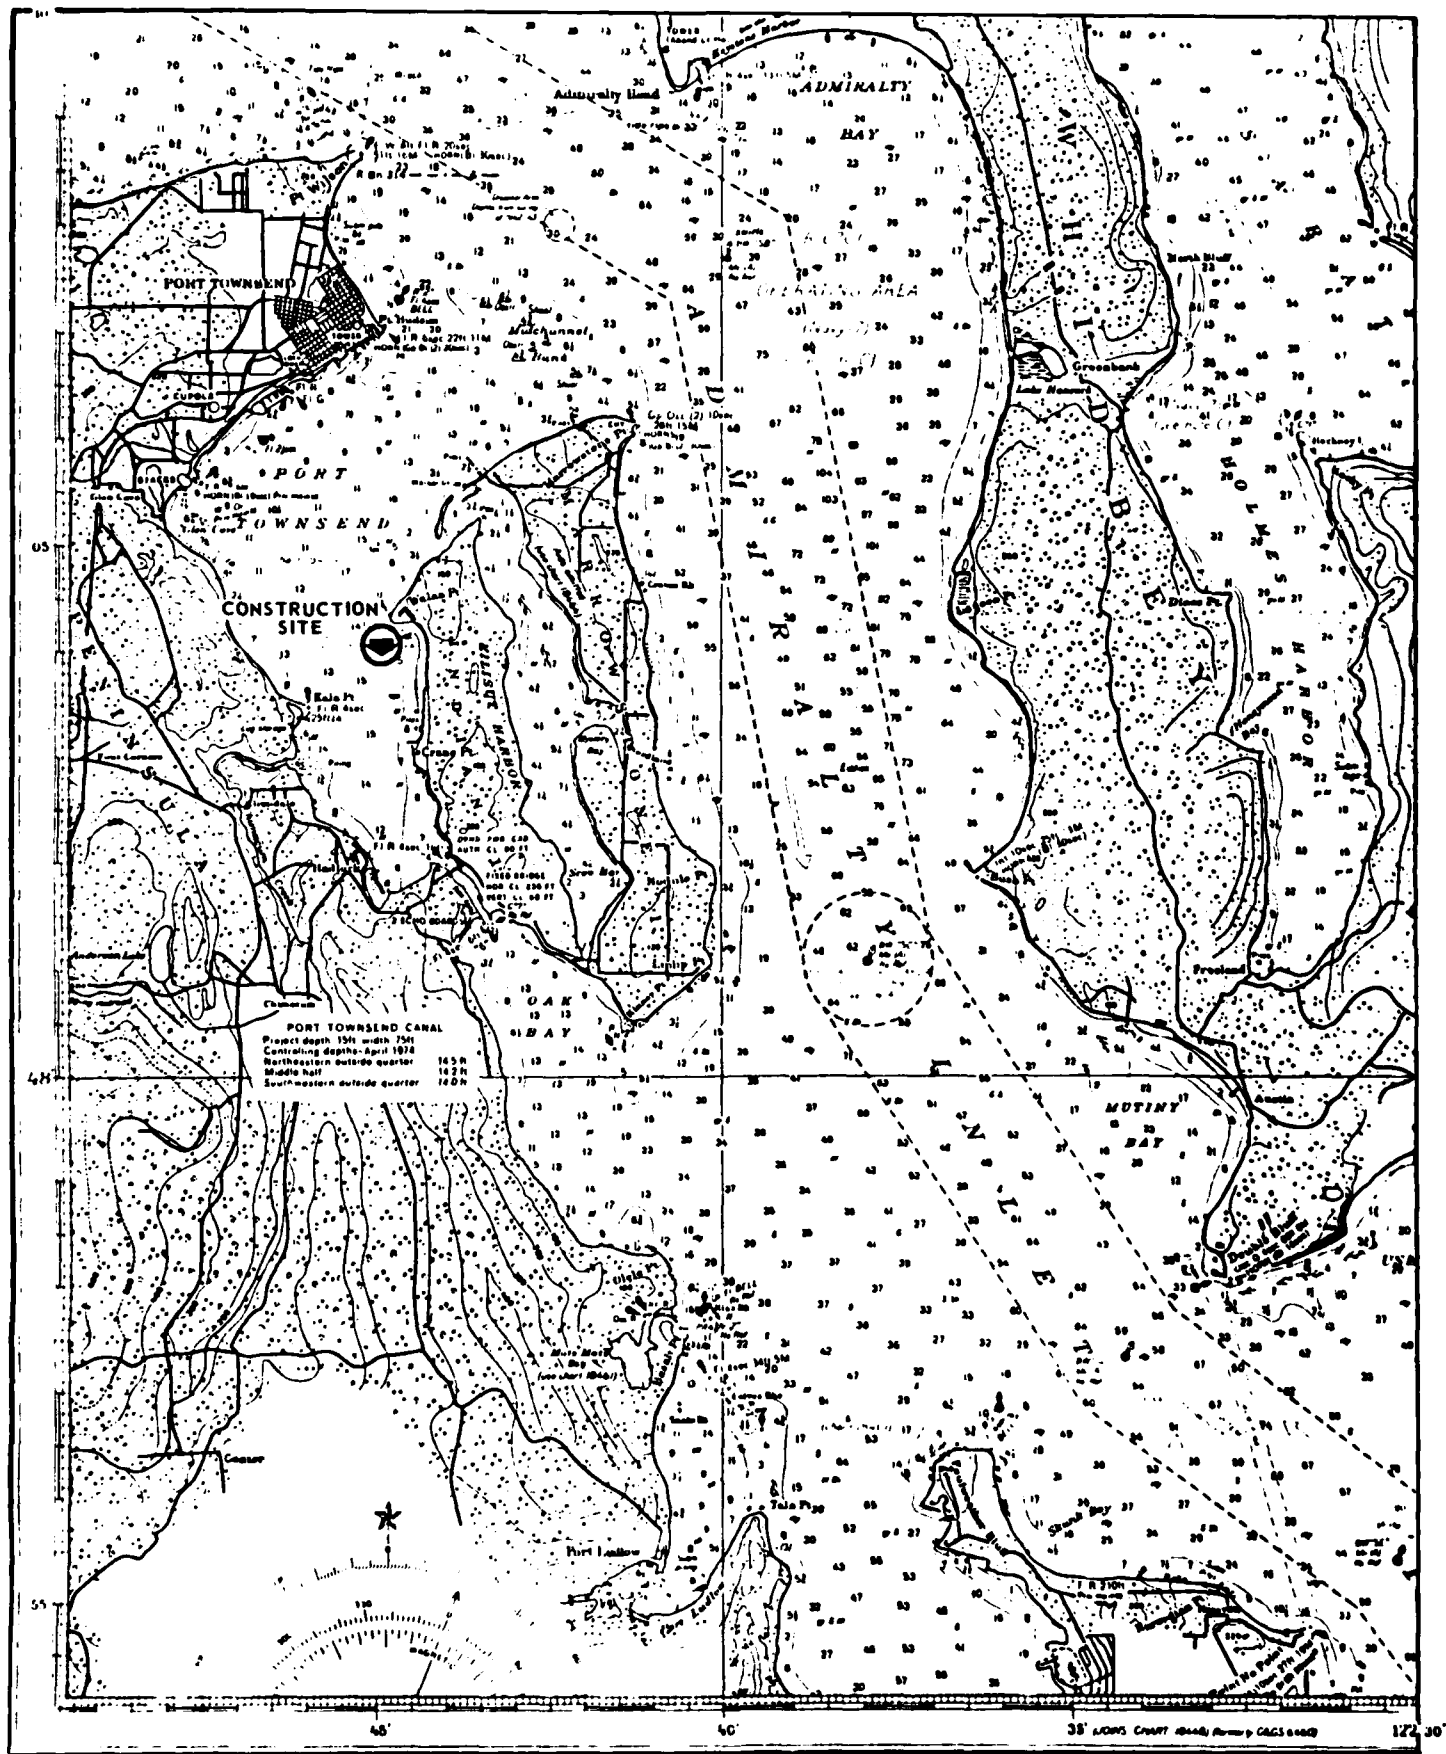
FIGURE 2-1

CHART OF ADMIRALTY INLET, PUGET SOUND SHOWING PROJECT AREA

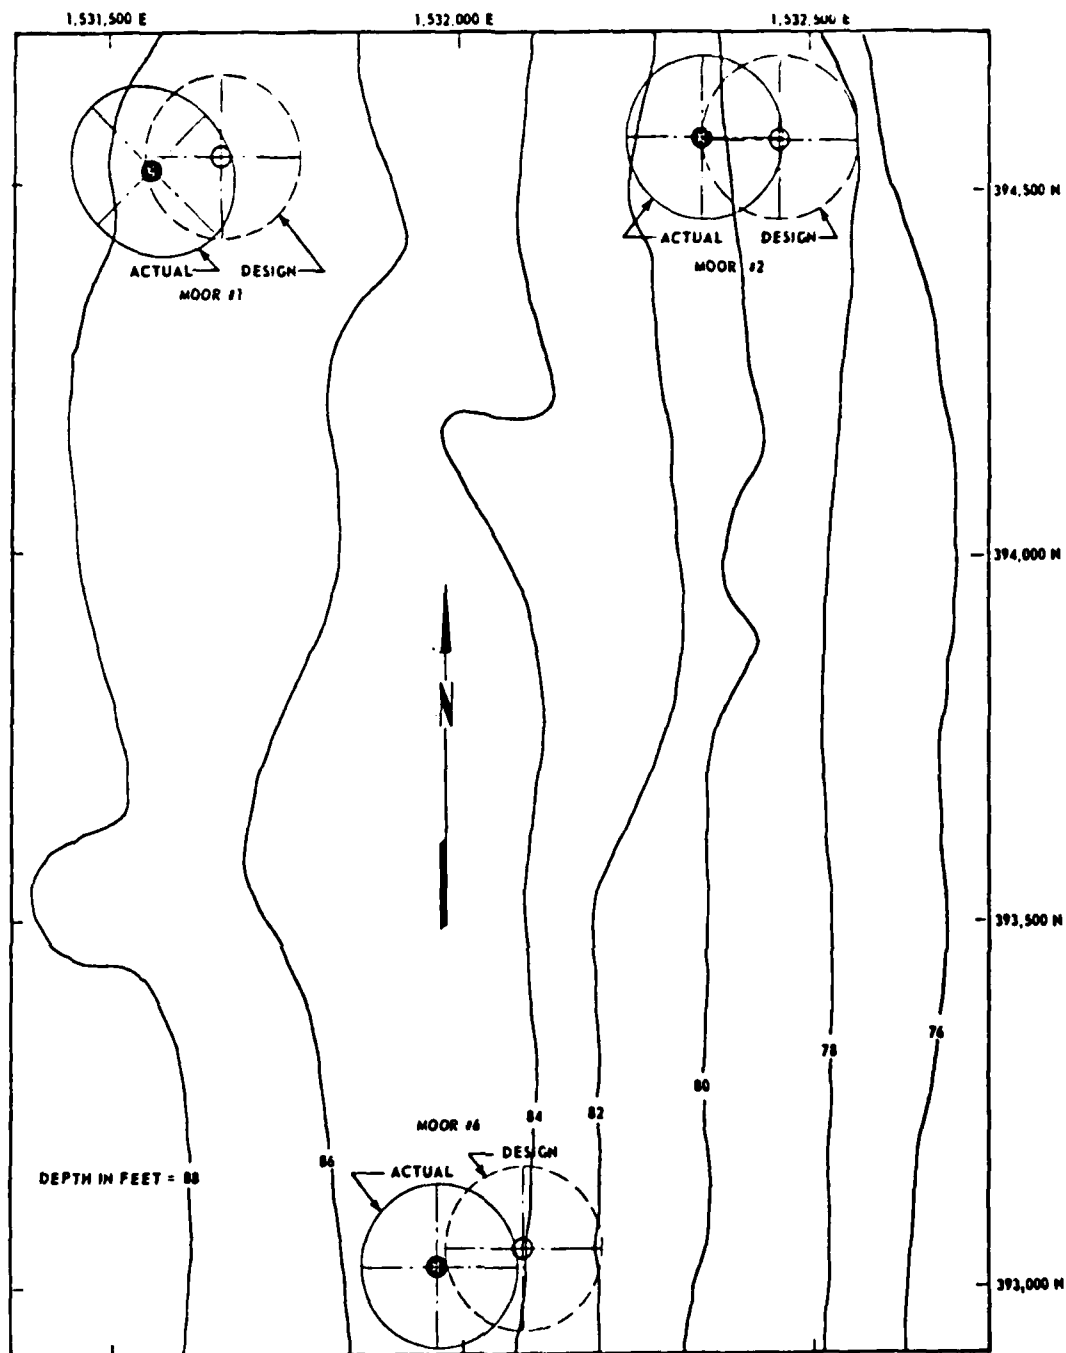
FIGURE 2-3

Due to navigational errors, the moorings installed in 1978 were installed approximately 100 feet west of their planned location as illustrated in Figure 2-3. The large circles indicate the planned and actual dislocation of the mooring buoys under a 12 kip load test. In working out the mooring spacings for the reinstallation of mooring number 1 and the locations for mooring numbers 3, 4, and 5, this installation inaccuracy was taken into account and mooring numbers 2 and 6 were to remain where they had been installed in 1978.

INSTALLATION LOCATION OF MOORINGS IN 1978

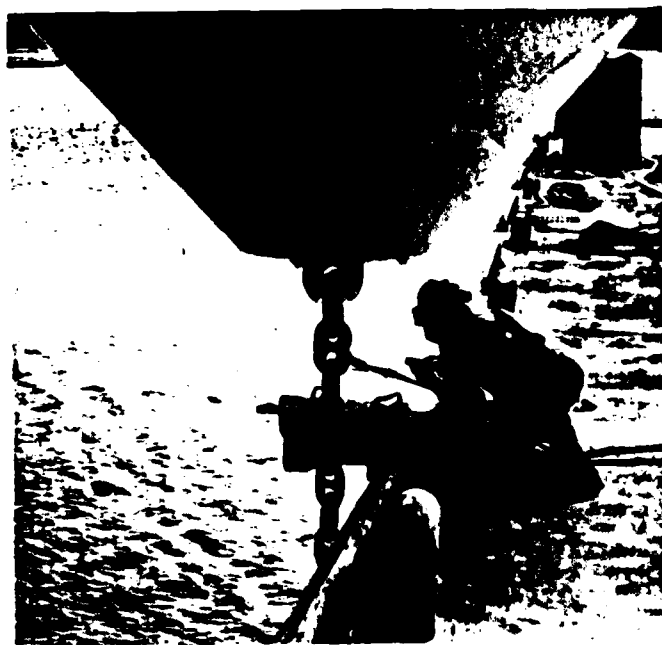
FIGURE 4-24

LOWERING EXCESS RISER CHAIN
ON TO CRANE BARGE DECK

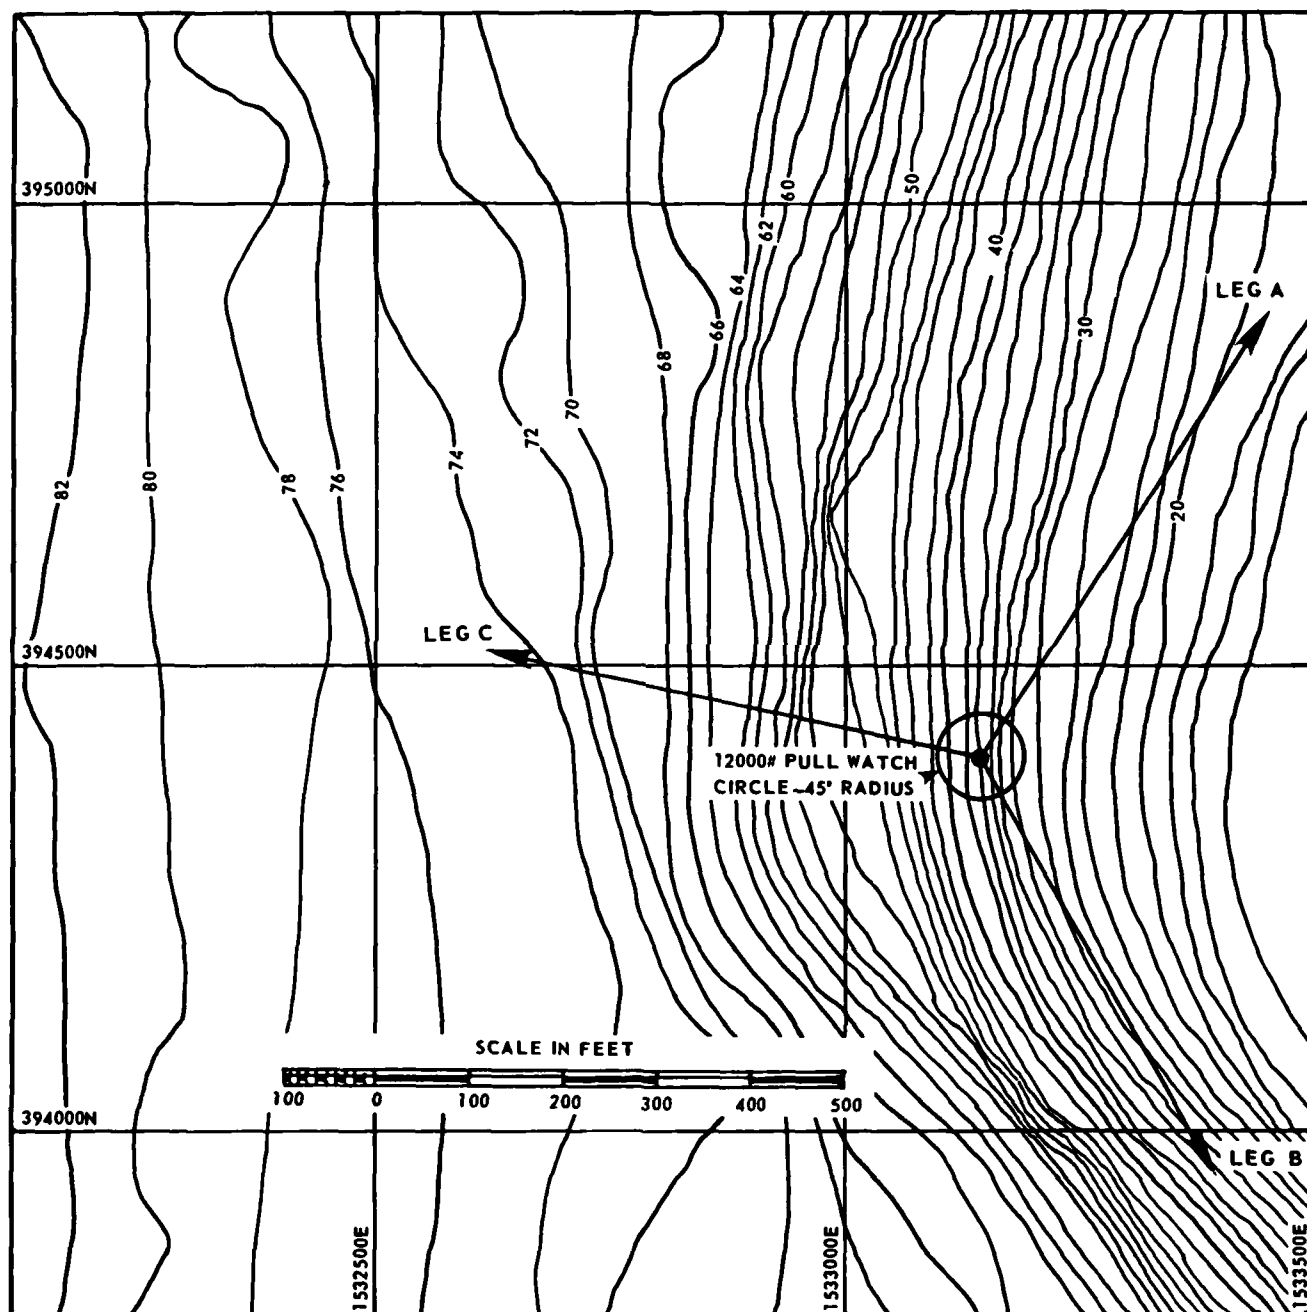
FIGURE 4-39

Returning now to the installation of Mooring Buoy #3, the pull test was conducted starting at 1026 on 3 September and completed at 1107. The results of this pull test, together with locations of the buoy and anchors, are shown in Figure 4-39. This completed the Phase II construction operations.

FINAL LOCATION OF MOORING BUOY #3 RELATIVE TO
WASHINGTON STATE LAMBERT NORTH ZONE COORDINATES

Although the exact location of the mine shop is not certain, it appears that some change in the allowable ammunition load for barges moored to buoy #3 might be in order. The curve of ammunition weight versus distance to critical shore points indicates that reduction of the load from 150 kips to 144 kips would be required to compensate for the discrepancy in the position of buoy #3. It is therefore recommended that the specified loading for barges moored to this buoy be reduced to 125 kips.

In the development of as-built information for this report, it became clear that Mooring Buoy #3 had been positioned approximately 50 feet closer to the mine shop, Building 189, than was intended. When the watch circle of the stern of an ammunition barge swinging about this mooring is calculated, it is found that the watch circle overlaps the 2350-foot ESQD radius from the mine shop. Because of this, it is recommended that the allowable storage capacity of barges using Mooring #3 be reduced from 150 kilopounds of ammunition to 125 kilopounds. It is also recommended that an accurate survey of the mine shop be performed.

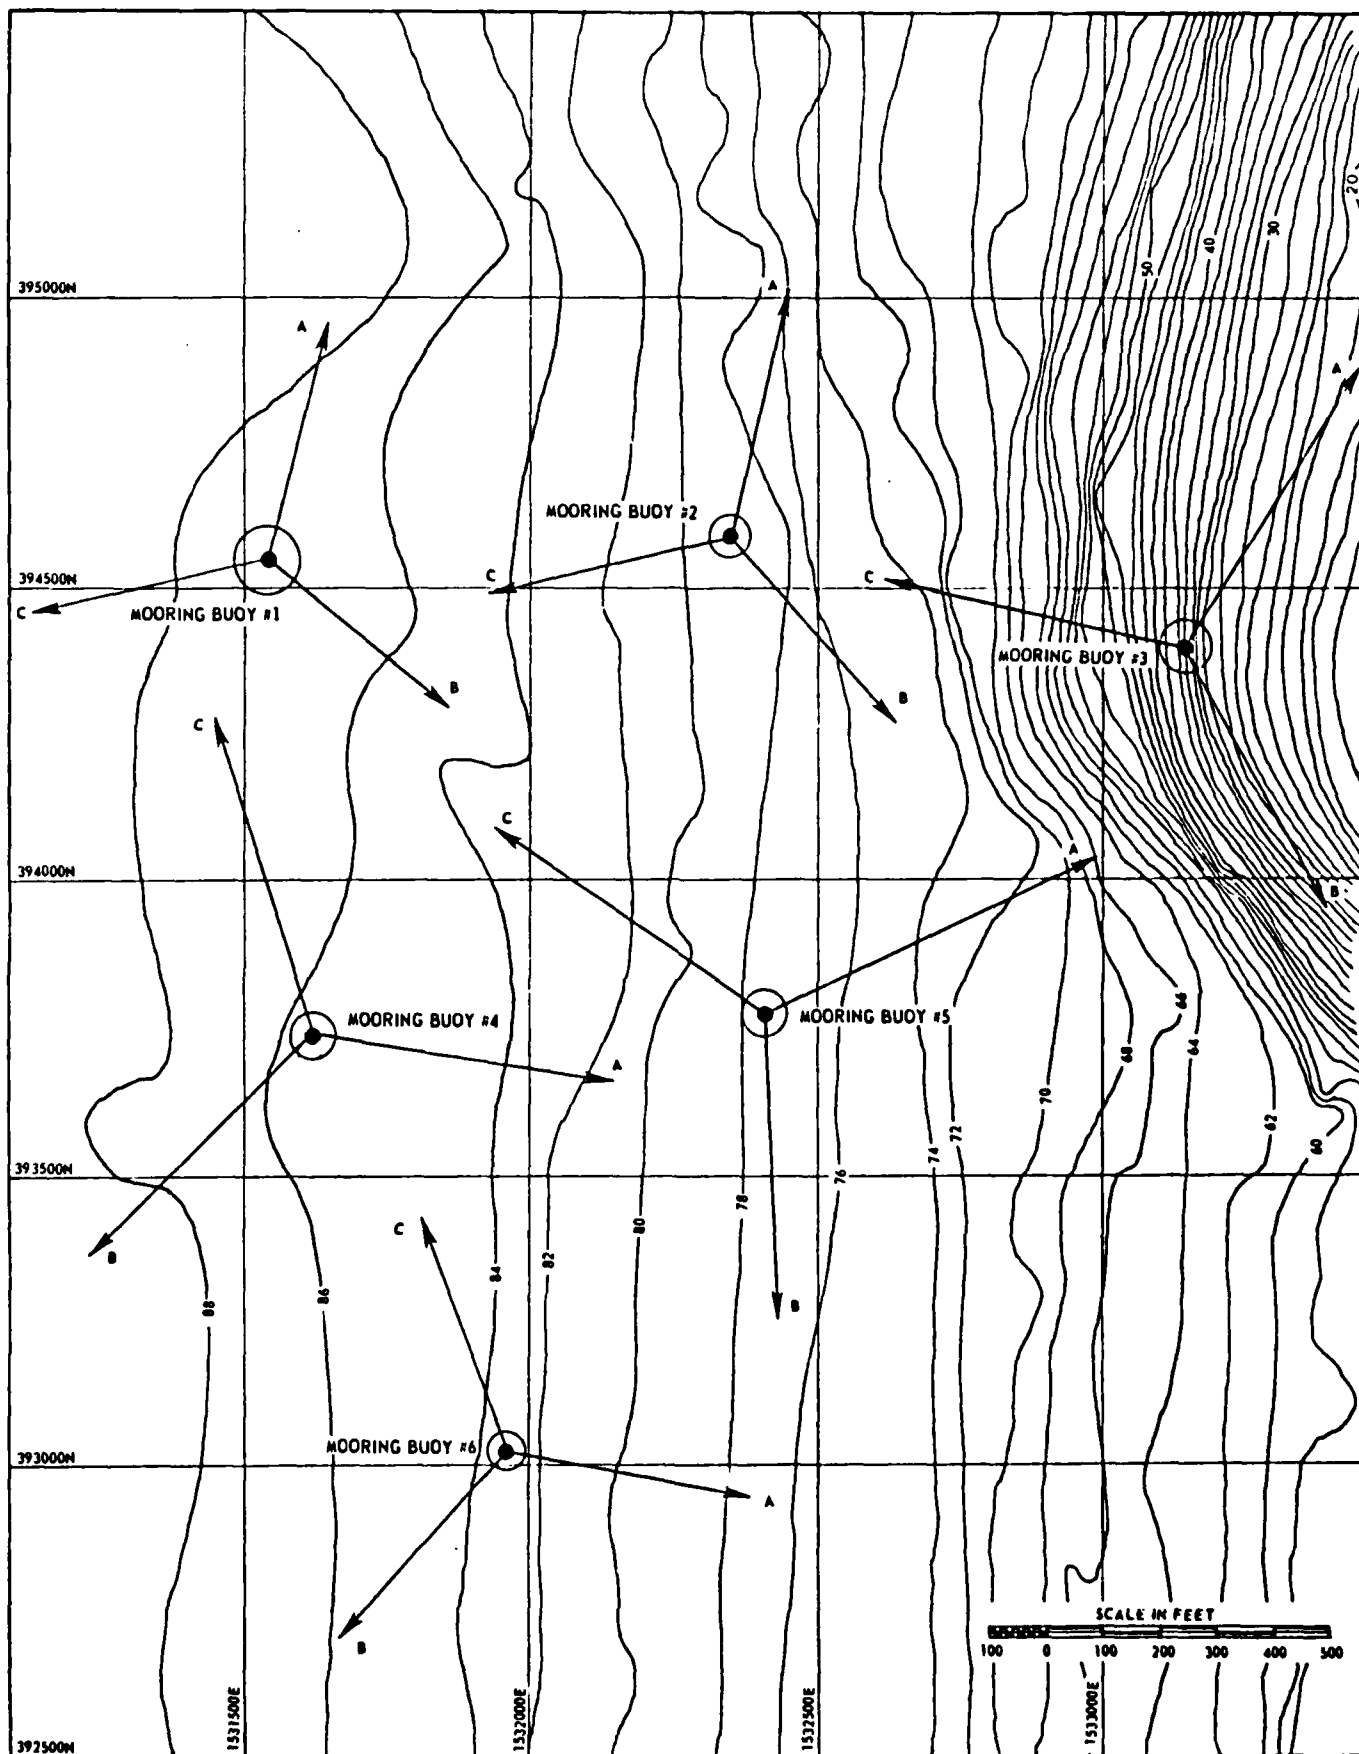
FIGURE 5-2

The locations of the mooring buoys, as sighted in by transit from Cliff and Walan, are tabulated below in Washington State Coordinates in feet. The anchor locations shown by the arrow heads on Figure 5-2, and the anchor coordinate tabulation below, are at the last sighted location of the respective crown buoys for these anchors.

AS-BUILT LOCATIONS OF INDIAN ISLAND MOORINGS RELATIVE
TO WASHINGTON STATE LAMBERT NORTH ZONE COORDINATES
